**Flood Control Project Maintenance
Levee Inspections**

Maintenance Issue Types Only, Levee Inspection Report By Mile - Spring 2016

San Joaquin County Flood Control and Water Conservation District

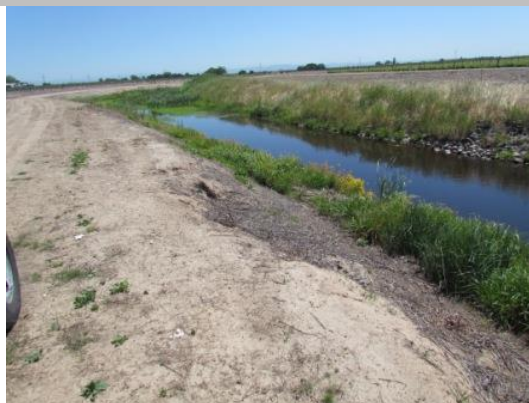
Photo 2 of 2 : SP_2016_NA0017_158_4_20160219_00005.jpg

View of erosion that was found on the waterside of the levee.

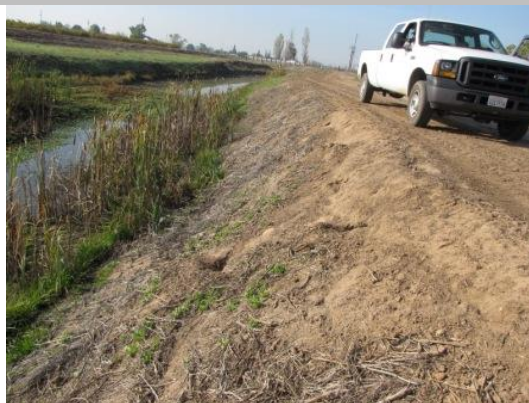
Photo 1 of 1 : SP_2016_NA0017_158_1_20160219_00001.jpg

LM Start	0.64	Rating **	M	Issue No.	1
LM End	0.64	Issue Type +	Ma	Location *	WS
Category	Earthen Levee			GPS Latitude/Longitude	
				Start	End
Item	Animal Control			38.112050 °	38.112050 °
				-121.149524 °	-121.149524 °
DWR ID	DWR_NA0017_14_s_2012_1				
Comment Code					
A1 : Exterminate rodents and backfill and compact or grout burrows.					
Inspector Comment

View of rodent holes in the waterward berm looking downstream.

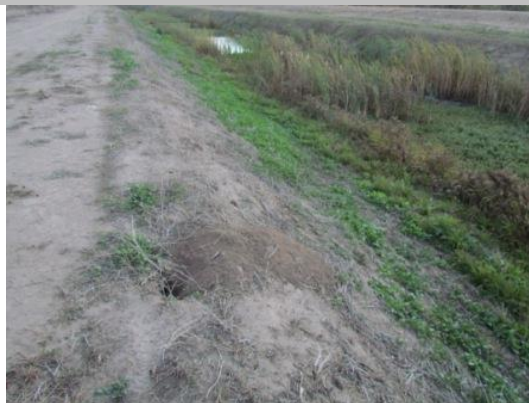
Photo 1 of 1 : SP_2016_NA0017_158_3_20160219_00003.jpg

LM Start	0.72	Rating **	M	Issue No.	3
LM End	0.72	Issue Type +	Ma	Location *	WS
Category	Earthen Levee			GPS Latitude/Longitude	
				Start	End
Item	Animal Control			38.111851 °	38.111851 °
				-121.148358 °	-121.148358 °
DWR ID	DWR_NA0017_14_s_2012_3				
Comment Code					
A3 : No rodents visible, but rodent burrows visible; need to backfill and compact or grout burrows.					
Inspector Comment

View of a rodent hole that was found on the waterside shoulder of the levee looking upstream.

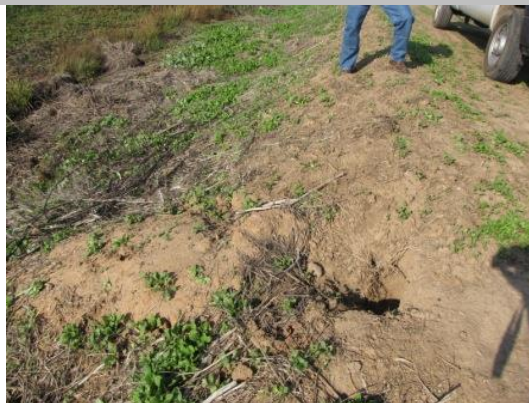
Photo 1 of 1 : SP_2016_NA0017_158_2_20160219_00002.jpg

LM Start	0.81	Rating **	M	Issue No.	2
LM End	0.81	Issue Type +	Ma	Location *	WS
Category	Earthen Levee			GPS Latitude/Longitude	
				Start	End
Item	Animal Control			38.110628 °	38.110628 °
				-121.147429 °	-121.147429 °
DWR ID	DWR_NA0017_14_s_2012_2				
Comment Code					
A1 : Exterminate rodents and backfill and compact or grout burrows.					
Inspector Comment

View of a large diameter rodent hole in the waterward berm looking downstream.

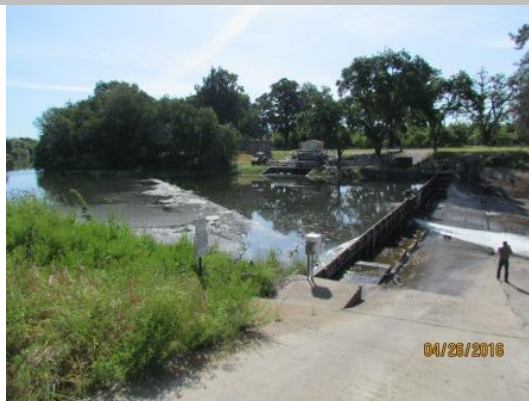
Photo 1 of 1 : SP_2016_NA0017_159_1155_20160502_00305.jpg

LM Start	0.00	Rating **	A/W	Issue No.	1155
LM End	0.00	Issue Type +	Ma	Location *	WS
Category	Interior Drainage & Piping Systems			GPS Latitude/Longitude	
				Start	End
Item	Vegetation & Obstructions			0.000000 °	0.000000 °
				0.000000 °	0.000000 °
DWR ID	DWR_NA0017_15_s_2014_1155				
Comment Code					
Inspector Comment					
This is the Upper Calaveras river channel. No levee exists.

View of the dam at the starting of the Mormon slough.

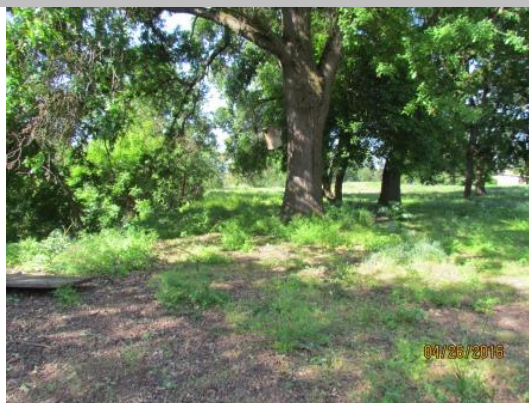
Photo 1 of 1 : SP_2016_NA0017_159_210_20160502_00306.jpg

LM Start	0.01	Rating **	U	Issue No.	210
LM End	0.23	Issue Type +	Ma	Location *	CR
Category	Earthen Levee			GPS Latitude/Longitude	
				Start	End
Item	Vegetation			38.052646 °	38.050071 °
				-121.011926 °	-121.014189 °
DWR ID	DWR_NA0017_15_s_2016_210				
Comment Code					
V1 : Control annual grass and weeds on the levee slopes and easements.					
Inspector Comment

View of the dense vegetation on the crown of the levee looking downstream.

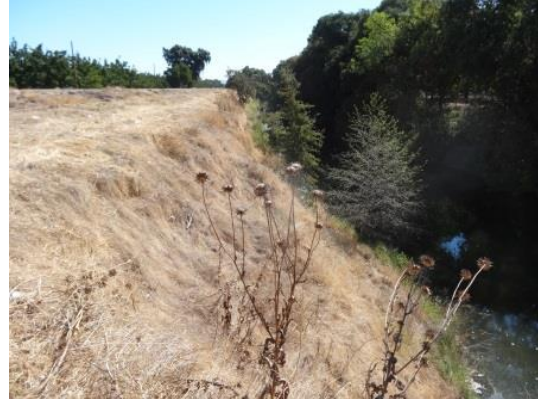
Photo 1 of 3 : SP_2016_NA0017_159_7_20160219_00010.jpg

LM Start	0.83	Rating **	M	Issue No.	7 (cont)
LM End	0.83	Issue Type +	Ma	Location *	WS

Downstream view of the site.

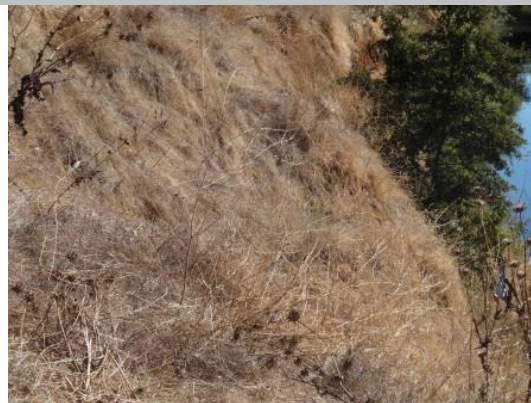
Photo 3 of 3 : SP_2016_NA0017_159_7_20160219_00012.jpg

Comment Code						
Inspector Comment						
8/12/2015: No significant change observed.						
8/20/2014: No significant change has been observed.						
9/12/2013: No significant change observed.						
08/22/2012: Site has been revisited. No significant change observed.						
09/02/2011: No significant change observed on site.						
11/02/2010: No significant change observed. The mile-long erosion continues to degrade the bank. There are a few trees along the mile-long stretch on the lower bank slope that are affected by the scarp. WS Levee Slope was changed to 2:1. As a result, normalized score increased from 62 to 65.						
08/05/2010: Recommended for waterside repair, per CLRO; "water velocity is a major factor for accelerating bank slope erosion."						
8/12/2009: Near-vertical bank erosion; degrading channel is incising the banks; recommend annual assessment and monitoring of critical erosion site, per CLRO CES Evaluation 2008 Report; district is monitoring site for change in condition; site was previously rated "U".

2007: Visited site 02/06/2007; possible critical site. [2015 Site ID:NA0017U15RM22.91]

Looking down at the site.

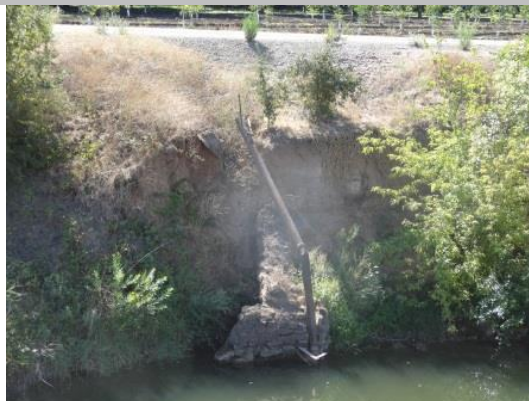
Photo 2 of 2 : SP_2016_NA0017_159_36_20160219_00058.jpg

LM Start	1.05	Rating **	U	Issue No.	36 (cont)	
LM End	1.07	Issue Type +	Ma	Location *	WS	
Category	Supplemental			GPS Latitude/Longitude		
				Start		End
Item	DWR Erosion Survey			38.043080 °		38.043080 °
				-121.026280 °		-121.026280 °
DWR ID	DWR_NA0017_15_s _ 2016_36					
Comment Code						
Inspector Comment						
8/12/2015: No significant change observed.						
8/20/2014: No significant change observed.						
09/12/2013: No significant change observed.						
08/22/2012: The erosion was surveyed and documented for monitoring purpose. There is no levee structure on the site, only high ground protecting the land behind. The levee crest width and levee height were not measured or estimated in the field.						
There is a drainage pipe at the site, which might have caused the problem at one pocket erosion. [2015 Site ID:NA0017U16RM22.74]

Close view of the erosion. Note the drainage pipe at the site.

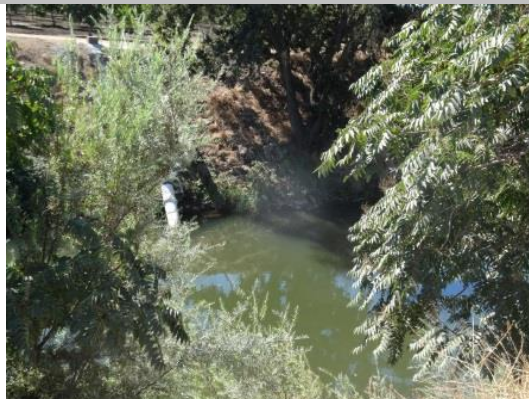
Photo 1 of 3 : SP_2016_NA0017_159_35_20160219_00054.jpg

LM Start	1.21	Rating **	U	Issue No.	35	
LM End	1.21	Issue Type +	Ma	Location *	WS	
Category	Supplemental			GPS Latitude/Longitude		
				Start	End	
Item	DWR Erosion Survey			38.041260 °	38.041260 °	
				-121.027730 °	-121.027730 °	
DWR ID	DWR_NA0017_15_s _ 2016_35					
Comment Code						
Inspector Comment						
8/12/2015: No significant change observed. 8/20/2014: No significant change observed. 9/12/2013: No significant change observed. 08/22/2012: The erosion is at the outside corner of a river bend, and next to a tree at the levee toe. Irrigation structure presents at the site. There is no levee structure on site. The levee crest width and levee height were not measured or estimated in the field. [2015 Site ID:NA0017U16RM22.58]

Front view of the erosion. The erosion is next to a tree at the levee toe.

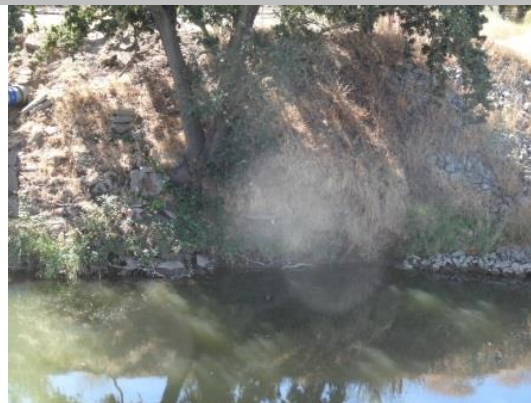
Photo 2 of 3 : SP_2016_NA0017_159_35_20160219_00055.jpg

LM Start	1.21	Rating **	U	Issue No.	35 (cont)	
LM End	1.21	Issue Type +	Ma	Location *	WS	
Category	Supplemental			GPS Latitude/Longitude		
				Start	End	
Item	DWR Erosion Survey			38.041260 °	38.041260 °	
				-121.027730 °	-121.027730 °	
DWR ID	DWR_NA0017_15_s_2016_35					
Comment Code						
Inspector Comment						
8/12/2015: No significant change observed. 8/20/2014: No significant change observed. 9/12/2013: No significant change observed. 08/22/2012: The erosion is at the outside corner of a river bend, and next to a tree at the levee toe. Irrigation structure presents at the site. There is no levee structure on site. The levee crest width and levee height were not measured or estimated in the field. [2015 Site ID:NA0017U16RM22.58]

Closer view of the erosion.

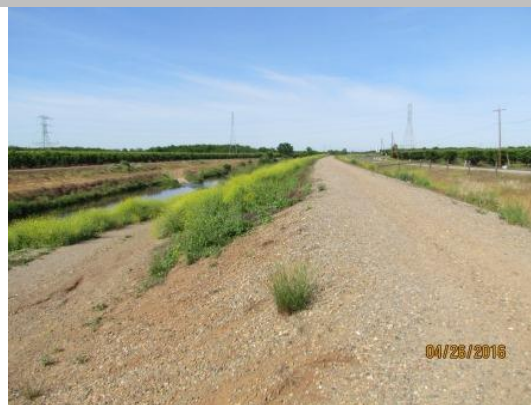
Photo 1 of 1 : SP_2016_NA0017_159_211_20160502_00307.jpg

LM Start	1.26	Rating **	M	Issue No.	211
LM End	4.05	Issue Type +	Ma	Location *	WS
Category	Earthen Levee			GPS Latitude/Longitude	
				Start	End
Item	Vegetation			38.040894 °	38.016203 °
				-121.028646 °	-121.067121 °
DWR ID	DWR_NA0017_15_s_2016_211				
Comment Code					
V1 : Control annual grass and weeds on the levee slopes and easements.					
Inspector Comment

View of the vegetation on the waterside of the levee.

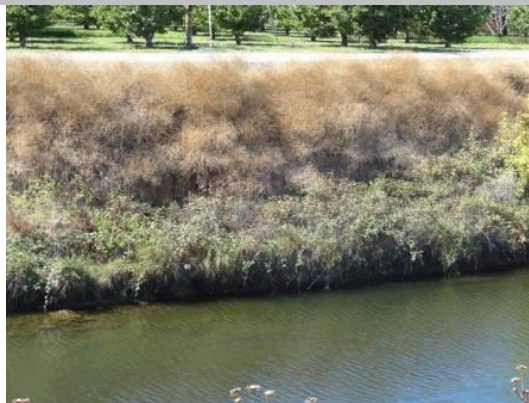
Photo 2 of 3 : SP_2016_NA0017_159_33_20160219_00051.jpg

LM Start	1.64	Rating **	M	Issue No.	33 (cont)	
LM End	1.64	Issue Type +	Ma	Location *	WS	
Category	Supplemental			GPS Latitude/Longitude		
				Start	End	
Item	DWR Erosion Survey			38.039940 °	38.039940 °	
				-121.035430 °	-121.035430 °	
DWR ID	DWR_NA0017_15_s_2016_33					
Comment Code						
Inspector Comment						
8/12/2015: No significant change observed. 8/20/2014: No significant change observed. 9/12/2013: No significant change observed. 08/22/2012: The berm is estimated at 10 ft. Dense vegetation on site. There is no levee structure on site. The levee crest width and levee height were not measured or estimated in the field. [2015 Site ID:NA0017U16RM22.15]

Close view of the erosion.

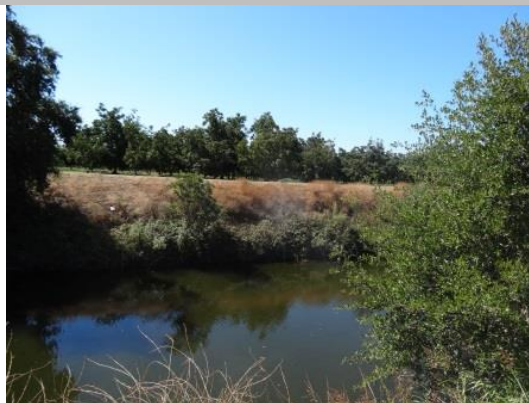
Photo 1 of 3 : SP_2016_NA0017_159_29_20160219_00044.jpg

LM Start	1.78	Rating **	U	Issue No.	29
LM End	1.79	Issue Type +	Ma	Location *	WS
Category	Supplemental			GPS Latitude/Longitude	
				Start	End
Item	DWR Erosion Survey			38.039110 °	38.039110 °
				-121.037840 °	-121.037840 °
DWR ID	DWR_NA0017_15_s _ 2016_29				
Comment Code					
Inspector Comment					
8/12/2015: No significant change observed.					
8/20/2014: No significant change observed.					
9/12/2013: No significant change observed.					
08/22/2012: Site is covered with dense vegetation. A scarp erosion is adjacent to a pocket erosion at the downstream. There is no levee structure on site. The levee crest width and levee height were not measured or estimated in the field. [2015 Site ID:NA0017U16RM22.01]

Front view of the erosion site from the left river bank.

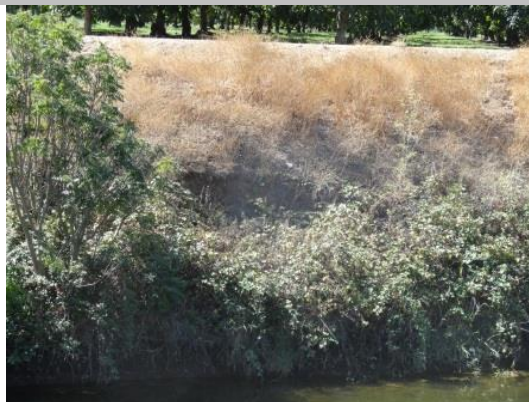
Photo 2 of 3 : SP_2016_NA0017_159_29_20160219_00045.jpg

LM Start	1.78	Rating **	U	Issue No.	29 (cont)
LM End	1.79	Issue Type +	Ma	Location *	WS

Front view of the pocket erosion.

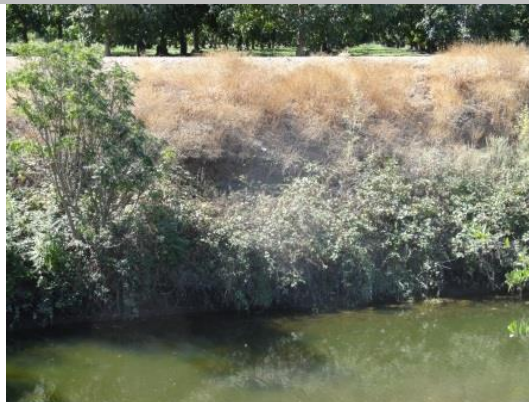
Photo 3 of 3 : SP_2016_NA0017_159_29_20160219_00046.jpg

LM Start	1.78	Rating **	U	Issue No.	29 (cont)
LM End	1.79	Issue Type +	Ma	Location *	WS

Close view of the erosion.

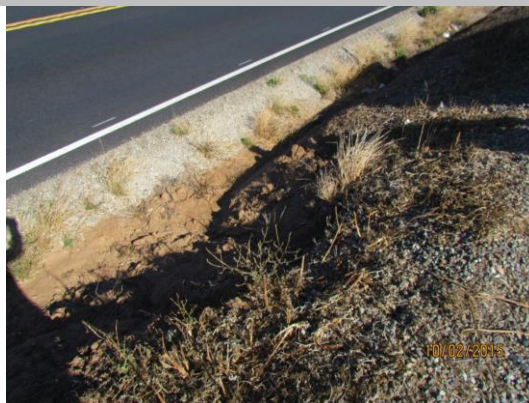
Photo 1 of 1 : SP_2016_NA0017_159_120_20160219_00105.jpg

LM Start	1.92	Rating **	M	Issue No.	120
LM End	1.92	Issue Type +	Ma	Location *	LS
Category	Earthen Levee			GPS Latitude/Longitude	
				Start	End
Item	Slope Stability			38.037919 °	38.037919 °
				-121.039749 °	-121.039749 °
DWR ID	DWR_NA0017_15_f_2015_120				
Comment Code					
S1 : Repair slope instability.					
Inspector Comment					
It was caused by runoff.

A slope instability possible cause by runoff on the landside of the levee looking upstream.

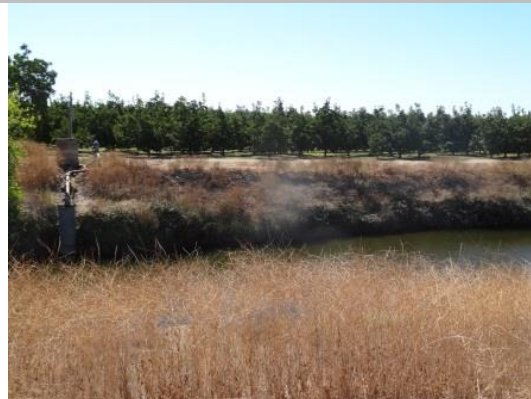
Photo 1 of 3 : SP_2016_NA0017_159_28_20160219_00041.jpg

LM Start	1.98	Rating **	M	Issue No.	28
LM End	2.00	Issue Type +	Ma	Location *	WS
Category	Supplemental			GPS Latitude/Longitude	
				Start	End
Item	DWR Erosion Survey			38.037150 °	38.037150 °
				-121.040580 °	-121.040580 °
DWR ID	DWR_NA0017_15_s _ 2016_28				
Comment Code					
Inspector Comment					
8/12/2015: No significant change observed.					
8/20/2014: No significant change observed.					
9/12/2013: No significant change observed.					
08/22/2012: Berm width is estimated as 5 ft. There is no levee structure on site. The levee crest width and levee height were not measured or estimated in the field. [2015 Site ID:NA0017U16RM21.05]

Front view of the erosion

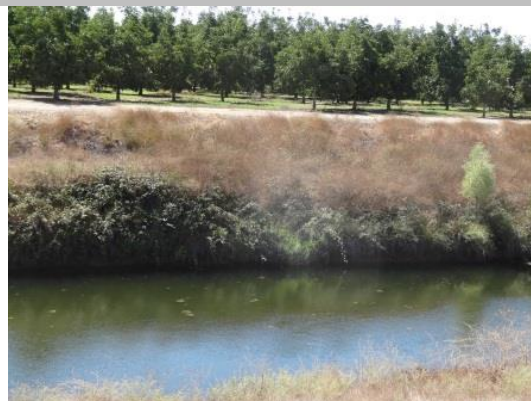
Photo 2 of 3 : SP_2016_NA0017_159_28_20160219_00042.jpg

Close view of the erosion.

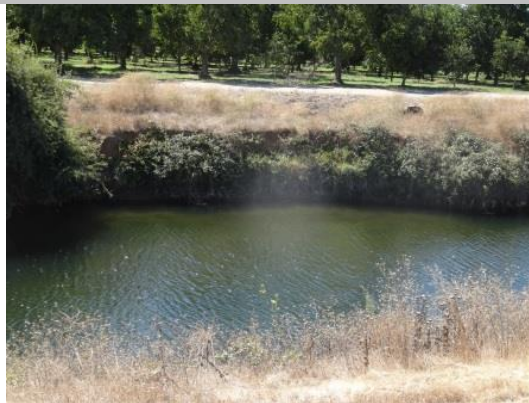
Photo 1 of 3 : SP_2016_NA0017_159_26_20160219_00037.jpg

LM Start	2.36	Rating **	M	Issue No.	26
LM End	2.37	Issue Type +	Ma	Location *	WS
Category	Supplemental			GPS Latitude/Longitude	
				Start	End
Item	DWR Erosion Survey			38.033072 °	38.033072 °
				-121.044970 °	-121.044970 °
DWR ID	DWR_NA0017_15_s _ 2016_26				
Comment Code					
Inspector Comment					
8/12/2015: No significant change observed.					
8/20/2014: No significant change observed.					
9/12/2013: No significant change observed.					
08/22/2012: Site is covered with dense vegetation. There is no levee structure on site. The levee crest width and levee height were not measured or estimated in the field. [2015 Site ID:NA0017U16RM20.71]

Front view of the site.

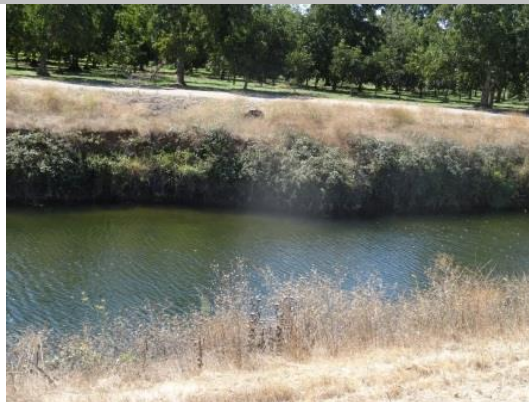
Photo 2 of 3 : SP_2016_NA0017_159_26_20160219_00038.jpg

Front view of the erosion. Site is covered with vegetation and trees.

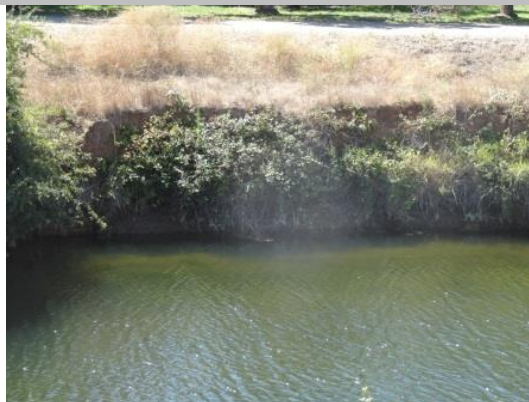
Photo 3 of 3 : SP_2016_NA0017_159_26_20160219_00039.jpg

Closer view of the erosion.

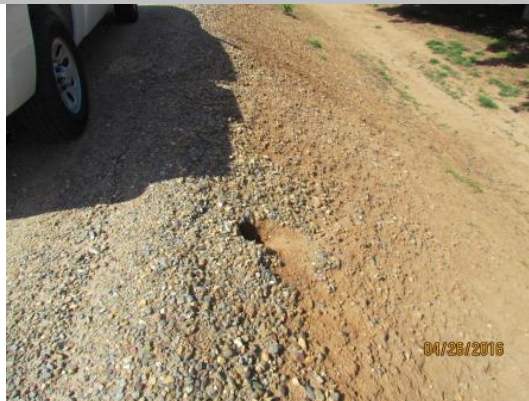
Photo 1 of 1 : SP_2016_NA0017_159_213_20160502_00309.jpg

LM Start	2.87	Rating **	M	Issue No.	213
LM End	2.87	Issue Type +	Ma	Location *	LS
Category	Earthen Levee			GPS Latitude/Longitude	
				Start	End
Item	Animal Control			38.027992 °	38.027992 °
				-121.051762 °	-121.051762 °
DWR ID	DWR_NA0017_15_s_2016_213				
Comment Code					
A3 : No rodents visible, but rodent burrows visible; need to backfill and compact or grout burrows.					
Inspector Comment

View of rodent holes on the landside shoulder of the levee.

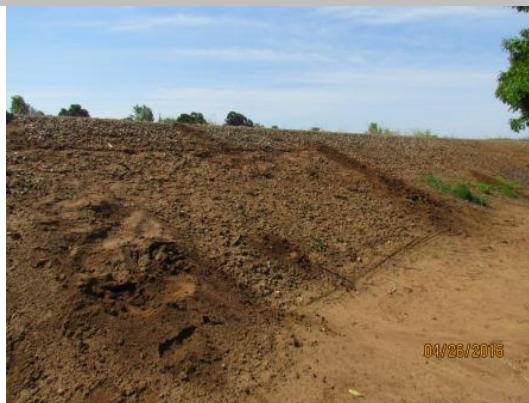
Photo 1 of 1 : SP_2016_NA0017_159_214_20160502_00310.jpg

LM Start	2.89	Rating **	M	Issue No.	214
LM End	2.89	Issue Type +	Ma	Location *	LS
Category	Earthen Levee			GPS Latitude/Longitude	
				Start	End
Item	Animal Control			38.027810 °	38.027810 °
				-121.052085 °	-121.052085 °
DWR ID	DWR_NA0017_15_s_2016_214				
Comment Code					
A3 : No rodents visible, but rodent burrows visible; need to backfill and compact or grout burrows.					
Inspector Comment					
Rodent hole was recently filled up but not grouted.

View of rodent holes on the landside slope of the levee.

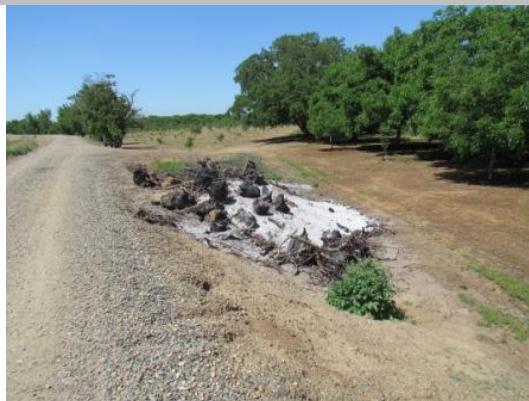
Photo 1 of 1 : SP_2016_NA0017_159_12_20160219_00020.jpg

LM Start	3.34	Rating **	M	Issue No.	12
LM End	3.34	Issue Type +	Ma	Location *	LS
Category	Earthen Levee			GPS Latitude/Longitude	
				Start	End
Item	Encroachments			38.023817 °	38.023817 °
				-121.058465 °	-121.058465 °
DWR ID	DWR_NA0017_15_s_2012_12				
Comment Code					
PR : Prunings					
Inspector Comment					
Burn pile has been burned but new material has been placed.

New material was placed at the toe of the landside of the levee. The picture was taken from the crown looking downstream.

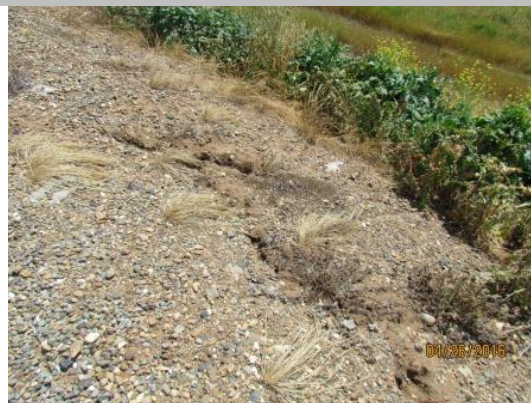
Photo 1 of 1 : SP_2016_NA0017_159_218_20160502_00312.jpg

LM Start	3.55	Rating **	M	Issue No.	218
LM End	3.55	Issue Type +	Ma	Location *	WS
Category	Earthen Levee			GPS Latitude/Longitude	
				Start	End
Item	Animal Control			38.021701 °	38.021701 °
				-121.061178 °	-121.061178 °
DWR ID	DWR_NA0017_15_s _ 2016_218				
Comment Code					
A3 : No rodents visible, but rodent burrows visible; need to backfill and compact or grout burrows.					
Inspector Comment

View of rodent holes on the waterside of the levee looking upstream.

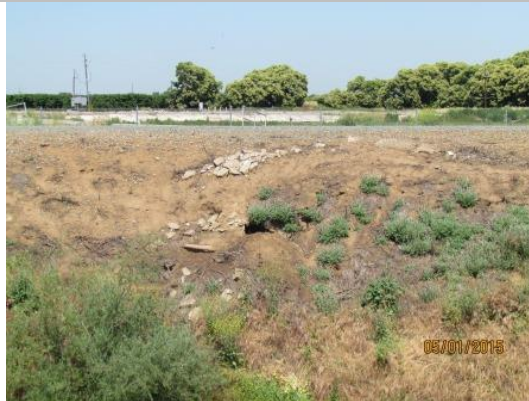
Photo 1 of 1 : SP_2016_NA0017_159_208_20160219_00144.jpg

LM Start	3.77	Rating **	M	Issue No.	208
LM End	3.77	Issue Type +	Ma	Location *	WS
Category	Earthen Levee			GPS Latitude/Longitude	
				Start	End
Item	Animal Control			38.019026 °	38.019026 °
				-121.063479 °	-121.063479 °
DWR ID	DWR_NA0017_15_s_2015_208				
Comment Code					
A3 : No rodents visible, but rodent burrows visible; need to backfill and compact or grout burrows.					
Inspector Comment

A rodent hole was found on the waterside of the levee. The picture was taken from the opposite side of the levee.

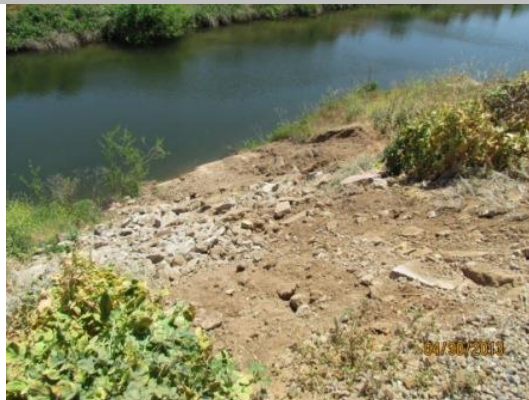
Photo 1 of 2 : SP_2016_NA0017_159_43_20160219_00062.jpg

LM Start	3.78	Rating **	M	Issue No.	43
LM End	3.78	Issue Type +	Ma	Location *	WS
Category	Earthen Levee			GPS Latitude/Longitude	
				Start	End
Item	Slope Stability			38.019119 °	38.019119 °
				-121.064034 °	-121.064034 °
DWR ID	DWR_NA0017_15_f_2012_43				
Comment Code					
S1 : Repair slope instability.					
Inspector Comment

Updated picture of the slope instability on the waterside slope of the levee looking downstream.

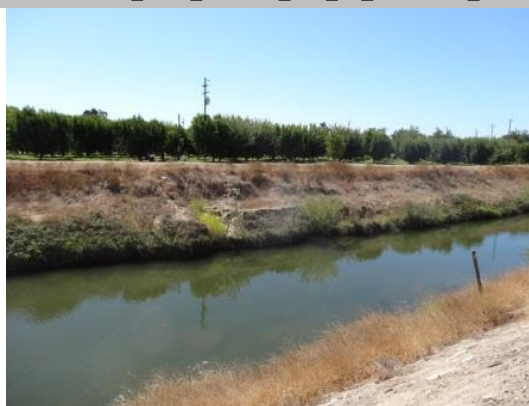
Photo 1 of 3 : SP_2016_NA0017_159_17_20160219_00025.jpg

LM Start	3.87	Rating **	M	Issue No.	17
LM End	3.89	Issue Type +	Ma	Location *	WS
Category	Supplemental			GPS Latitude/Longitude	
				Start	End
Item	DWR Erosion Survey			38.018100 °	38.018100 °
				-121.065170 °	-121.065170 °
DWR ID	DWR_NA0017_15_s_2016_17				
Comment Code					
Inspector Comment					
8/12/2015: No significant change observed. 8/20/2014: No significant change observed. 9/12/2013: No significant change observed. 08/22/2012: River-induced erosion occurred on the berm, while the runoff-induced erosion occurred on the levee slope. Site is covered with vegetation. There is no levee structure on site. The levee crest width and levee height were not measured or estimated in the field. [2015 Site ID:NA0017U16RM19.18]

View of the site from right river bank.

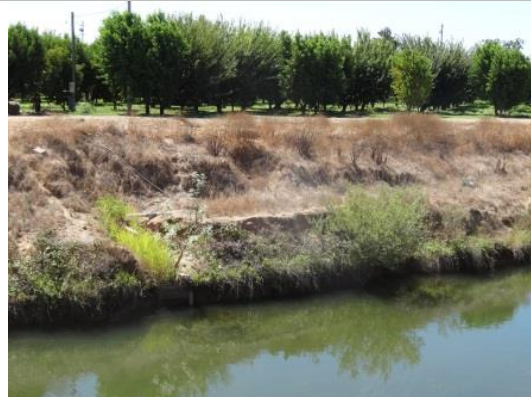
Photo 2 of 3 : SP_2016_NA0017_159_17_20160219_00026.jpg

Closer view of the erosion.

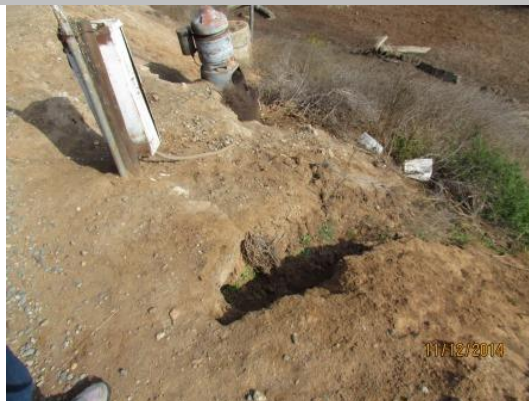
Photo 1 of 2 : SP_2016_NA0017_159_44_20160219_00064.jpg

LM Start	3.89	Rating **	M	Issue No.	44
LM End	3.89	Issue Type +	Ma	Location *	WS
Category	Earthen Levee			GPS Latitude/Longitude	
				Start	End
Item	Slope Stability			38.017945 °	38.017945 °
				-121.065295 °	-121.065295 °
DWR ID	DWR_NA0017_15_f_2012_44				
Comment Code					
S1 : Repair slope instability.					
Inspector Comment

Updated picture of the slope instability on the waterside slope of the levee looking upstream. This picture was taken during fall 2014 inspection.

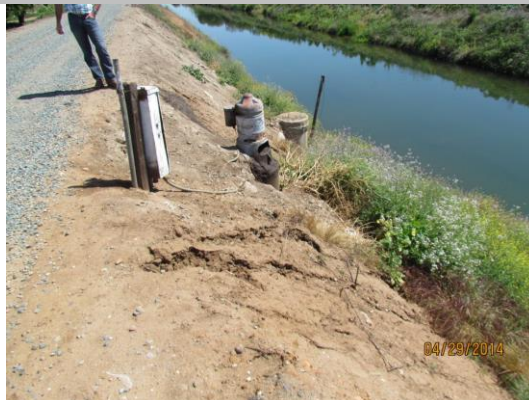
Photo 2 of 2 : SP_2016_NA0017_159_44_20160219_00065.jpg

View of the slope instability on the waterside slope of the levee looking downstream during spring 2014 inspection.

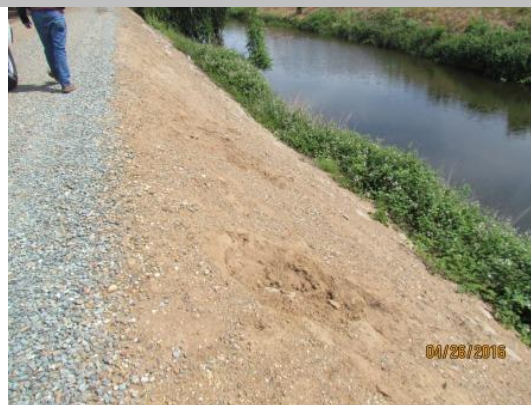
Photo 1 of 1 : SP_2016_NA0017_159_219_20160502_00313.jpg

LM Start	4.13	Rating **	M	Issue No.	219
LM End	4.13	Issue Type +	Ma	Location *	WS
Category	Earthen Levee			GPS Latitude/Longitude	
				Start	End
Item	Animal Control			38.015008 °	38.015008 °
				-121.067477 °	-121.067477 °
DWR ID	DWR_NA0017_15_s_2016_219				
Comment Code					
A3 : No rodents visible, but rodent burrows visible; need to backfill and compact or grout burrows.					
Inspector Comment

View of rodent holes on the waterside of the levee looking upstream.

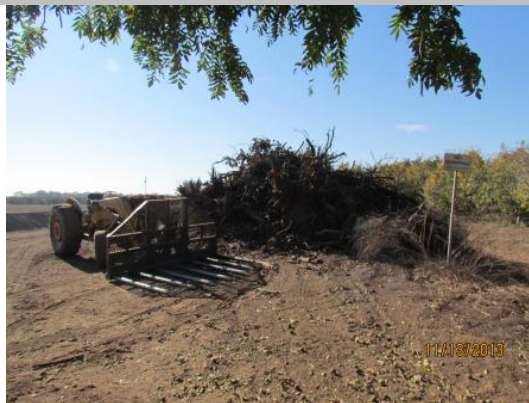
Photo 1 of 2 : SP_2016_NA0017_159_19_20160219_00030.jpg

LM Start	4.20	Rating **	M	Issue No.	19
LM End	4.20	Issue Type +	Ma	Location *	LS
Category	Earthen Levee			GPS Latitude/Longitude	
				Start	End
Item	Encroachments			38.014025 °	38.014025 °
				-121.067983 °	-121.067983 °
DWR ID	DWR_NA0017_15_s_2012_19				
Comment Code					
PR : Prunings					
Inspector Comment					
Burn pile has been burned but new material has been placed.

Updated picture of the prunings pile on the landside of the levee looking downstream during fall 2013 inspection.

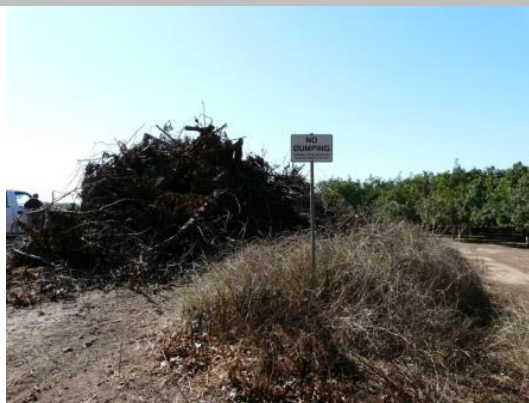
Photo 2 of 2 : SP_2016_NA0017_159_19_20160219_00031.jpg

Example of a prunings pile immediately adjacent to access road.
Evidence of habitual burnings at this site.

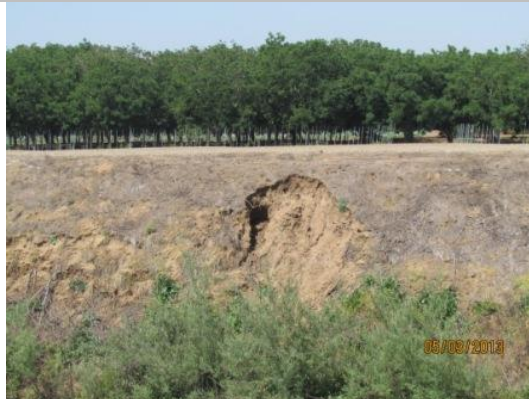
Photo 1 of 1 : SP_2016_NA0017_159_124_20160219_00107.jpg

LM Start	4.28	Rating **	U	Issue No.	124
LM End	4.28	Issue Type +	Ma	Location *	WS
Category	Earthen Levee			GPS Latitude/Longitude	
				Start	End
Item	Animal Control			38.012910 °	38.012910 °
				-121.067996 °	-121.067996 °
DWR ID	DWR_NA0017_15_s_2013_124				
Comment Code					
A3 : No rodents visible, but rodent burrows visible; need to backfill and compact or grout burrows.					
Inspector Comment					
Picture was taken from the other side of the levee.

An animal hole was found on the waterside slope of the levee. The picture was taken from the opposite side of the levee.

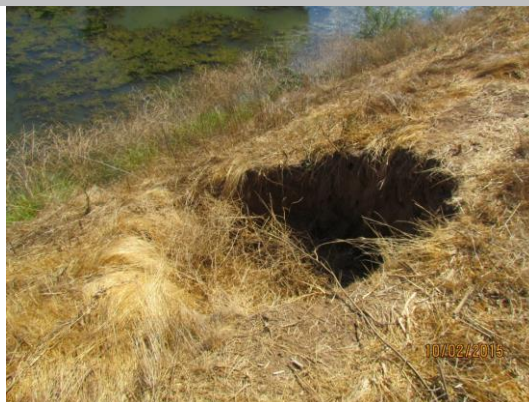
Photo 1 of 2 : SP_2016_NA0017_159_209_20160219_00145.jpg

LM Start	4.31	Rating **	M	Issue No.	209
LM End	4.31	Issue Type +	Ma	Location *	WS
Category	Earthen Levee			GPS Latitude/Longitude	
				Start	End
Item	Erosion / Bank Caving			38.012474 °	38.012474 °
				-121.068144 °	-121.068144 °
DWR ID	DWR_NA0017_15_s_2015_209				
Comment Code					
E2 : Schedule repair of erosion site prior to the next inspection.					
Inspector Comment					
It was started from rodent holes.

View of the erosion caused by an animal hole on the waterside shoulder of the levee looking downstream.

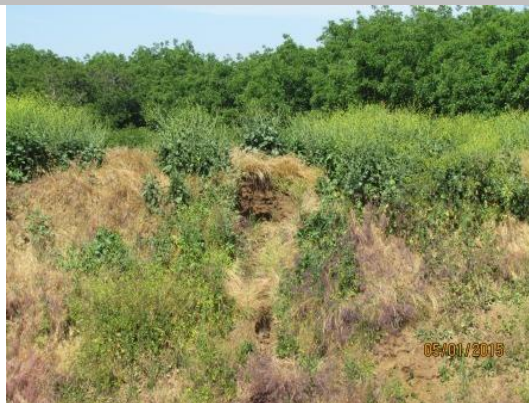
Photo 2 of 2 : SP_2016_NA0017_159_209_20160219_00146.jpg

LM Start	4.31	Rating **	M	Issue No.	209 (cont)	
LM End	4.31	Issue Type +	Ma	Location *	WS	
Category	Earthen Levee			GPS Latitude/Longitude		
				Start		End
Item	Erosion / Bank Caving			38.012474 °		38.012474 °
				-121.068144 °		-121.068144 °
DWR ID	DWR_NA0017_15_s_2015_209					
Comment Code						
E2 : Schedule repair of erosion site prior to the next inspection.						
Inspector Comment						
It was started from rodent holes.

A large rodent hole was found on the waterside of the levee. The picture was taken across the levee.

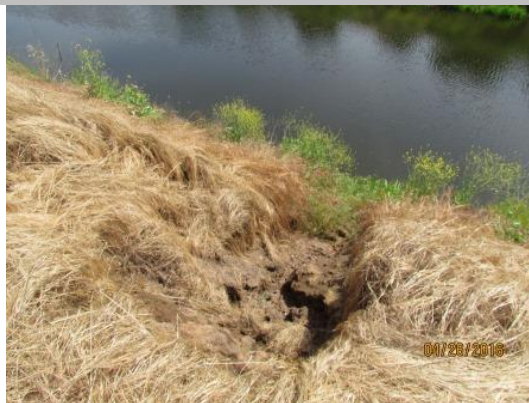
Photo 1 of 2 : SP_2016_NA0017_159_133_20160503_00314.jpg

LM Start	4.51	Rating **	M	Issue No.	133
LM End	4.51	Issue Type +	Ma	Location *	WS
Category	Earthen Levee			GPS Latitude/Longitude	
				Start	End
Item	Erosion / Bank Caving			38.009753 °	38.009753 °
				-121.069559 °	-121.069559 °
DWR ID	DWR_NA0017_15_f_2015_133				
Comment Code					
E2 : Schedule repair of erosion site prior to the next inspection.					
Inspector Comment

Updated view of the erosion on the waterside shoulder during spring 2016 inspection.

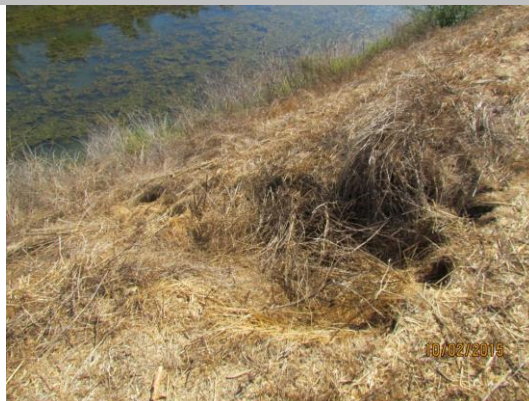
Photo 2 of 2 : SP_2016_NA0017_159_133_20160219_00112.jpg

LM Start	4.51	Rating **	M	Issue No.	133 (cont)	
LM End	4.51	Issue Type +	Ma	Location *	WS	
Category	Earthen Levee			GPS Latitude/Longitude		
				Start		End
Item	Erosion / Bank Caving			38.009753 °		38.009753 °
				-121.069559 °		-121.069559 °
DWR ID	DWR_NA0017_15_f_2015_133					
Comment Code						
E2 : Schedule repair of erosion site prior to the next inspection.						
Inspector Comment

Erosion was found on the waterside shoulder of the levee looking downstream.

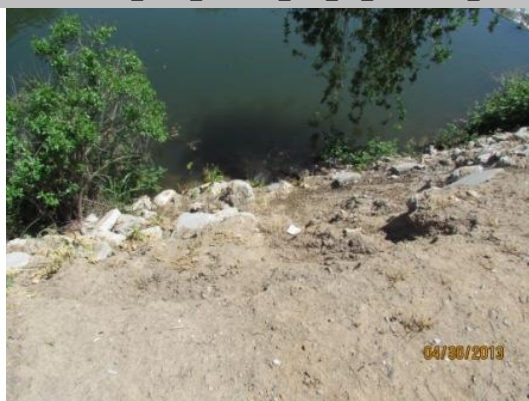
Photo 1 of 3 : SP_2016_NA0017_159_96_20160219_00091.jpg

LM Start	4.63	Rating **	M	Issue No.	96
LM End	4.63	Issue Type +	Ma	Location *	WS
Category	Earthen Levee			GPS Latitude/Longitude	
				Start	End
Item	Erosion / Bank Caving			38.008053 °	38.008053 °
				-121.070141 °	-121.070141 °
DWR ID	DWR_NA0017_15_s_2012_96				
Comment Code					
E1 : Note and monitor erosion site.					
Inspector Comment					
LMA has fixed the issue but the riprap has rebar which would can be dangerous during the flood fighting efforts.

Updated picture of the slope instability on the waterside slope of the levee looking downstream during spring 2013 inspection.

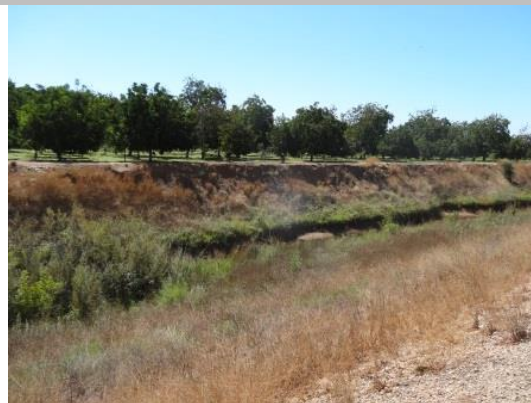
Photo 1 of 2 : SP_2016_NA0017_159_11_20160219_00018.jpg

8/12/2015: No significant change observed.
 8/20/2014: No significant change observed.
 9/12/2013: Site has been surveyed and the pocket erosion has developed toward levee crest.
 08/22/2012: A pocket erosion at the levee toe and on lower slope. The levee surface at the upper slope also shows signs of erosion due to poor maintenance. There is no levee structure on site. The levee crest width and levee height were not measured or estimated in the field.
 [2015 Site ID:NA0017U16RM17.99]

LM Start	4.98	Rating **	U	Issue No.	11 (cont)
LM End	4.98	Issue Type +	Ma	Location *	WS

View from right river bank.

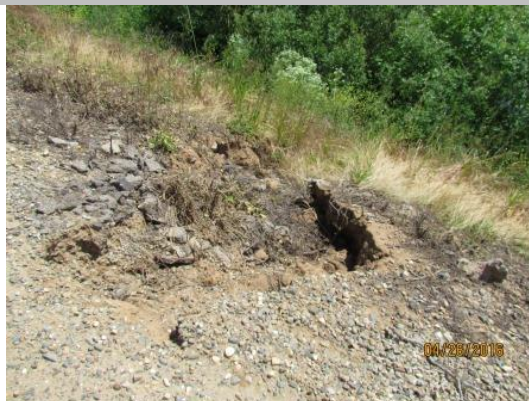
Photo 1 of 2 : SP_2016_NA0017_159_171_20160503_00315.jpg

LM Start	5.03	Rating **	M	Issue No.	171
LM End	5.03	Issue Type +	Ma	Location *	WS
Category	Earthen Levee			GPS Latitude/Longitude	
				Start	End
Item	Erosion / Bank Caving			38.003105 °	38.003105 °
				-121.073585 °	-121.073585 °
DWR ID	DWR_NA0017_15_f_2014_171				
Comment Code					
E2 : Schedule repair of erosion site prior to the next inspection.					
Inspector Comment					
Bank Caving.

Updated picture of the slope instability on the waterside of the levee during spring 2016 inspection.

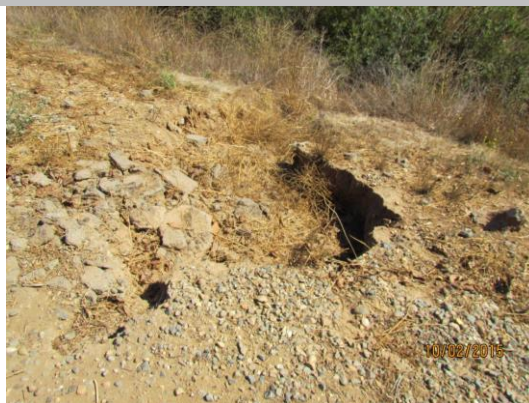
Photo 2 of 2 : SP_2016_NA0017_159_171_20160219_00129.jpg

LM Start	5.03	Rating **	M	Issue No.	171 (cont)
LM End	5.03	Issue Type +	Ma	Location *	WS

View of the slope instability on the waterside of the levee looking upstream during fall 2015 inspection.

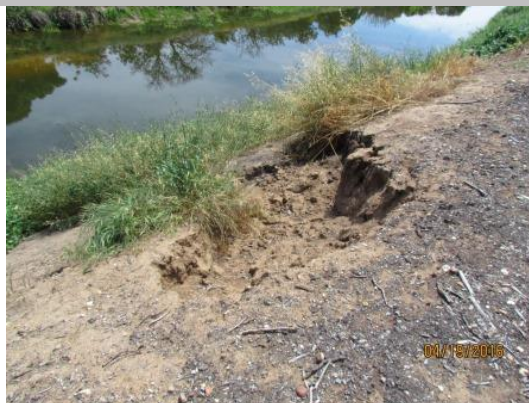
Photo 1 of 1 : SP_2016_NA0017_159_202_20160425_00303.jpg

LM Start	5.52	Rating **	M	Issue No.	202
LM End	5.52	Issue Type +	Ma	Location *	WS
Category	Earthen Levee			GPS Latitude/Longitude	
				Start	End
Item	Erosion / Bank Caving			37.997257 °	37.997257 °
				-121.078775 °	-121.078775 °
DWR ID	DWR_NA0017_15_s _ 2016_202				
Comment Code					
E2 : Schedule repair of erosion site prior to the next inspection.					
Inspector Comment

View of an erosion on the waterside shoulder of the levee.

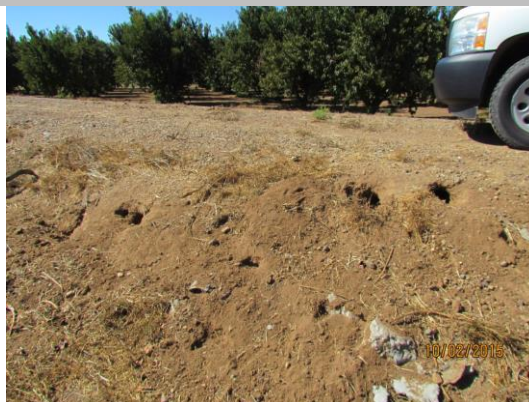
Photo 1 of 1 : SP_2016_NA0017_159_139_20160219_00115.jpg

LM Start	6.68	Rating **	M	Issue No.	139
LM End	6.68	Issue Type +	Ma	Location *	WS
Category	Earthen Levee			GPS Latitude/Longitude	
				Start	End
Item	Animal Control			37.983817 °	37.983817 °
				-121.091142 °	-121.091142 °
DWR ID	DWR_NA0017_15_f_2015_139				
Comment Code					
A3 : No rodents visible, but rodent burrows visible; need to backfill and compact or grout burrows.					
Inspector Comment

Rodent holes were found on the waterside of the levee.

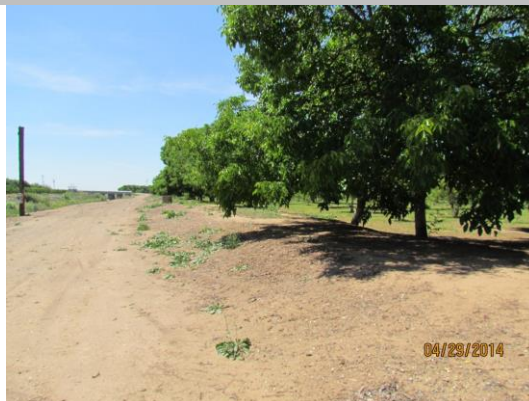
Photo 1 of 1 : SP_2016_NA0017_159_115_20160219_00103.jpg

LM Start	6.96	Rating **	M	Issue No.	115
LM End	7.20	Issue Type +	Ma	Location *	LS
Category	Earthen Levee			GPS Latitude/Longitude	
				Start	End
Item	Trim / Thin Trees			37.981387 °	37.979749 °
				-121.095370 °	-121.099178 °
DWR ID	DWR_NA0017_15_s_2014_115				
Comment Code					
T1 : Trim trees to at least five feet above ground level.					
Inspector Comment

Tree limbs were obstructing the visibility of the crown of the levee looking downstream.

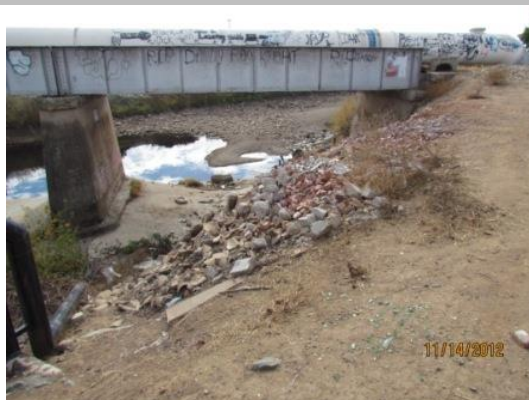
Photo 1 of 1 : SP_2016_NA0017_159_102_20160219_00095.jpg

LM Start	7.21	Rating **	M	Issue No.	102
LM End	7.21	Issue Type +	Ma	Location *	WS
Category	Earthen Levee			GPS Latitude/Longitude	
				Start	End
Item	Encroachments			37.979612 °	37.979612 °
				-121.099390 °	-121.099390 °
DWR ID	DWR_NA0017_15_s_2012_102				
Comment Code					
DE : Debris					
Inspector Comment

Debris was found on the waterside slope of the levee looking downstream.

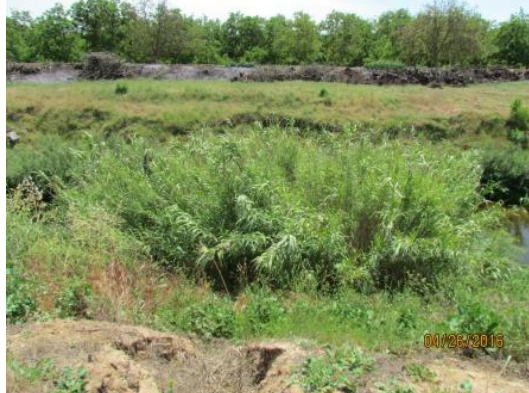
Photo 1 of 1 : SP_2016_NA0017_159_82_20160503_00316.jpg

LM Start	8.39	Rating **	M	Issue No.	82
LM End	8.39	Issue Type +	Ma	Location *	WS
Category	Earthen Levee			GPS Latitude/Longitude	
				Start	End
Item	Vegetation			37.969811 °	37.969811 °
				-121.116078 °	-121.116078 °
DWR ID	DWR_NA0017_15_s_2016_82				
Comment Code					
V2 : Remove the wild growth other than native grasses from the levee slopes.					
Inspector Comment					
Arundo on the waterside toe.

View of arundo on the waterside toe of the levee.

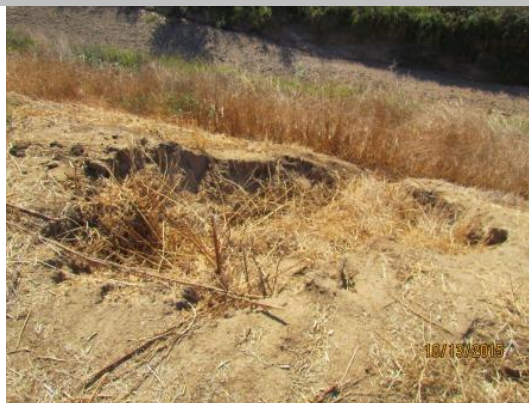
Photo 1 of 2 : SP_2016_NA0017_159_65_20160219_00076.jpg

LM Start	8.43	Rating **	M	Issue No.	65
LM End	8.43	Issue Type +	Ma	Location *	WS
Category	Earthen Levee			GPS Latitude/Longitude	
				Start	End
Item	Erosion / Bank Caving			37.969748 °	37.969748 °
				-121.116767 °	-121.116767 °
DWR ID	DWR_NA0017_15_s_2013_65				
Comment Code					
E2 : Schedule repair of erosion site prior to the next inspection.					
Inspector Comment

Updated picture of the slope instability on the waterside of the levee looking upstream during fall 2015 inspection.

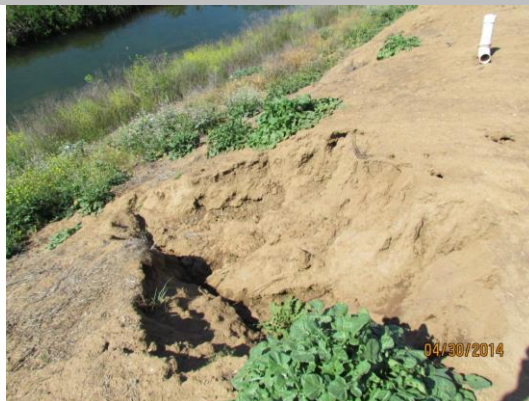
Photo 2 of 2 : SP_2016_NA0017_159_65_20160219_00077.jpg

LM Start	8.43	Rating **	M	Issue No.	65 (cont)	
LM End	8.43	Issue Type +	Ma	Location *	WS	
Category	Earthen Levee			GPS Latitude/Longitude		
				Start		End
Item	Erosion / Bank Caving			37.969748 °	37.969748 °	
				-121.116767 °	-121.116767 °	
DWR ID	DWR_NA0017_15_s_2013_65					
Comment Code						
E2 : Schedule repair of erosion site prior to the next inspection.						
Inspector Comment

View of the slope instability on the waterside of the levee looking downstream during spring 2014 inspection.

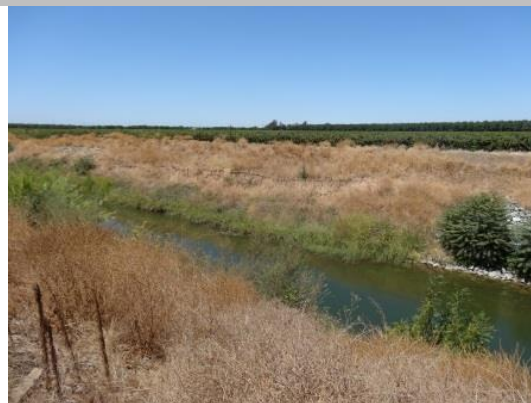
Photo 1 of 3 : SP_2016_NA0017_159_4_20160219_00003.jpg

LM Start	8.81	Rating **	M	Issue No.	4
LM End	8.83	Issue Type +	Ma	Location *	WS
Category	Supplemental			GPS Latitude/Longitude	
				Start	End
Item	DWR Erosion Survey			37.968060 °	37.968060 °
				-121.123299 °	-121.123299 °
DWR ID	DWR_NA0017_15_s _ 2016_4				
Comment Code					
Inspector Comment					
8/12/2015: No significant change observed.					
8/20/2014: Both ends of the erosion site are protected by riprap. [2015 Site ID:NA0017U15RM13.87]

View of the site from the left river bank.

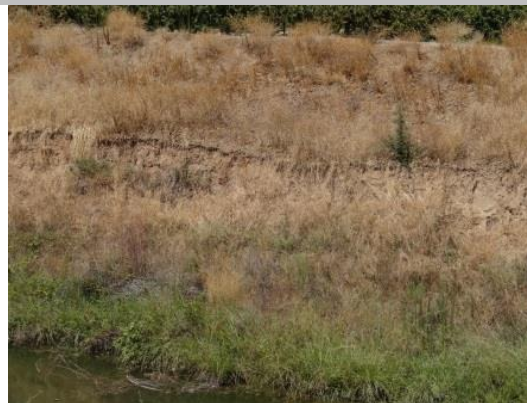
Photo 3 of 3 : SP_2016_NA0017_159_4_20160219_00005.jpg

LM Start	8.81	Rating **	M	Issue No.	4 (cont)	
LM End	8.83	Issue Type +	Ma	Location *	WS	
Category	Supplemental			GPS Latitude/Longitude		
				Start		End
Item	DWR Erosion Survey			37.968060 °		37.968060 °
				-121.123299 °		-121.123299 °
DWR ID	DWR_NA0017_15_s_2016_4					
Comment Code						
Inspector Comment						
8/12/2015: No significant change observed.						
8/20/2014: Both ends of the erosion site are protected by riprap. [2015 Site ID:NA0017U15RM13.87]

Close view of the erosion.

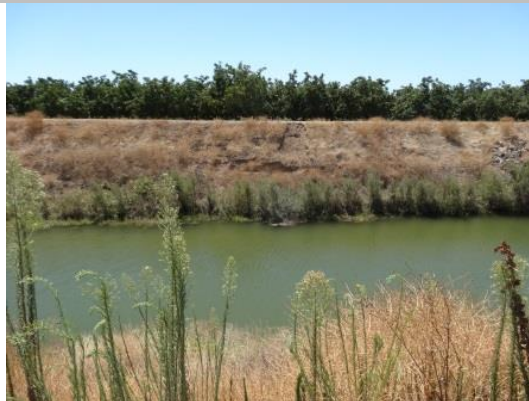
Photo 1 of 2 : SP_2016_NA0017_159_10_20160219_00016.jpg

LM Start	9.07	Rating **	U	Issue No.	10
LM End	9.07	Issue Type +	Ma	Location *	WS
Category	Supplemental			GPS Latitude/Longitude	
				Start	End
Item	DWR Erosion Survey			37.967019 °	37.967019 °
				-121.127581 °	-121.127581 °
DWR ID	DWR_NA0017_15_s _ 2016_10				
Comment Code					
Inspector Comment					
8/12/2015: No significant change observed.					
8/20/2014: No significant change observed.					
9/12/2013: The erosion might have been caused by river flow combined with runoff. Dense vegetation is presents at the site. There is no levee structure on site. The levee crest width and levee height were not measured or estimated in the field. [2015 Site ID:NA0017U16RM13.85]

View of the site from the right river bank.

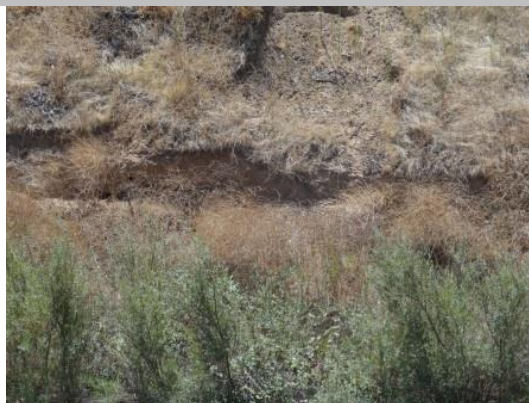
Photo 2 of 2 : SP_2016_NA0017_159_10_20160219_00017.jpg

LM Start	9.07	Rating **	U	Issue No.	10 (cont)
LM End	9.07	Issue Type +	Ma	Location *	WS

Close view of the erosion.

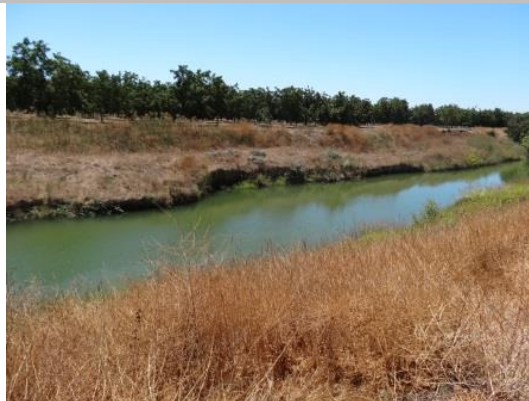
Photo 1 of 3 : SP_2016_NA0017_159_8_20160219_00013.jpg

LM Start	9.37	Rating **	M	Issue No.	8
LM End	9.39	Issue Type +	Ma	Location *	WS
Category	Supplemental			GPS Latitude/Longitude	
				Start	End
Item	DWR Erosion Survey			37.967190 °	37.967190 °
				-121.133080 °	-121.133080 °
DWR ID	DWR_NA0017_15_s _ 2016_8				
Comment Code					
Inspector Comment					
8/12/2015: No significant change observed.					
8/20/2014: No significant change observed.					
9/12/2013: No significant change observed.					
08/22/2012: The erosion is on berm. The berm width is estimated.					
There is no levee structure on site. The levee crest width and levee height were not measured or estimated in the field. [2015 Site ID:NA0017U16RM13.53]

Upstream view of the erosion.

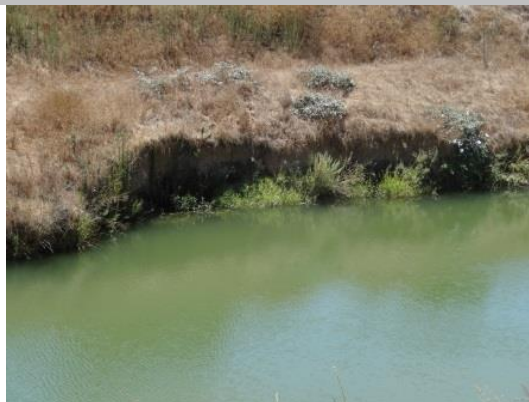
Photo 2 of 3 : SP_2016_NA0017_159_8_20160219_00014.jpg

Close view of the erosion.

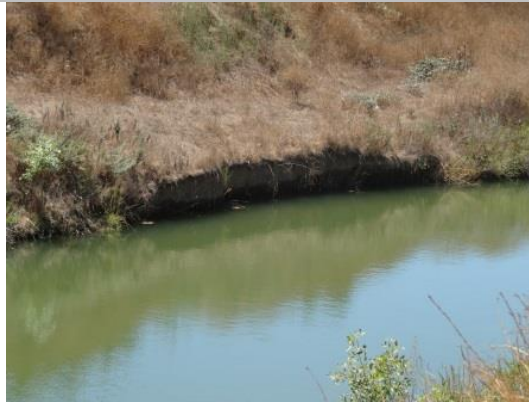
Photo 3 of 3 : SP_2016_NA0017_159_8_20160219_00015.jpg

LM Start	9.37	Rating **	M	Issue No.	8 (cont)
LM End	9.39	Issue Type +	Ma	Location *	WS

Close view of the erosion.

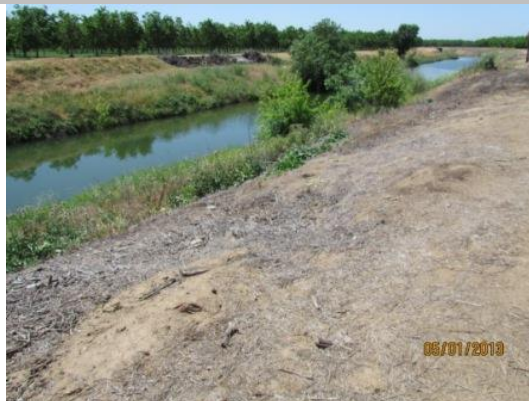
Photo 1 of 1 : SP_2016_NA0017_159_121_20160219_00106.jpg

LM Start	9.39	Rating **	M	Issue No.	121
LM End	9.39	Issue Type +	Ma	Location *	WS
Category	Earthen Levee			GPS Latitude/Longitude	
				Start	End
Item	Slope Stability			37.967155 °	37.967155 °
				-121.133277 °	-121.133277 °
DWR ID	DWR_NA0017_15_f_2012_121				
Comment Code					
S1 : Repair slope instability.					
Inspector Comment

A slope instability was found on the waterside slope of the levee looking downstream.

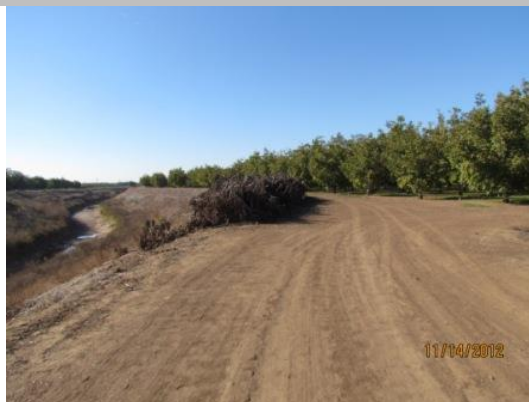
Photo 1 of 1 : SP_2016_NA0017_159_147_20160219_00120.jpg

LM Start	9.81	Rating **	M	Issue No.	147
LM End	9.81	Issue Type +	Ma	Location *	WS
Category	Earthen Levee			GPS Latitude/Longitude	
				Start	End
Item	Encroachments			37.965314 °	37.965314 °
				-121.140296 °	-121.140296 °
DWR ID	DWR_NA0017_15_s_2012_147				
Comment Code					
PR : Prunings					
Inspector Comment

Prunings were found on the waterside shoulder of the levee looking downstream.

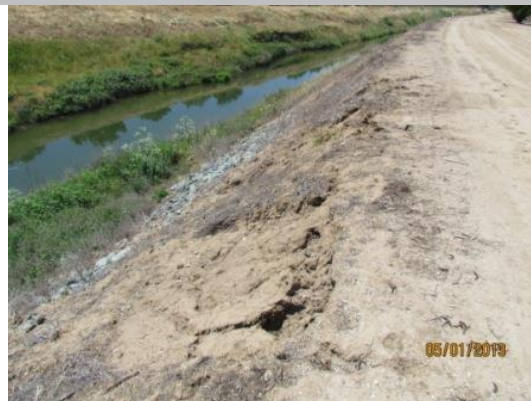
Photo 1 of 1 : SP_2016_NA0017_159_68_20160219_00080.jpg

LM Start	9.90	Rating **	M	Issue No.	68
LM End	9.90	Issue Type +	Ma	Location *	WS
Category	Earthen Levee			GPS Latitude/Longitude	
				Start	End
Item	Slope Stability			37.965165 °	37.965165 °
				-121.141928 °	-121.141928 °
DWR ID	DWR_NA0017_15_s_2013_68				
Comment Code					
S1 : Repair slope instability.					
Inspector Comment

Slope instability was found on the waterside slope of the levee looking downstream.

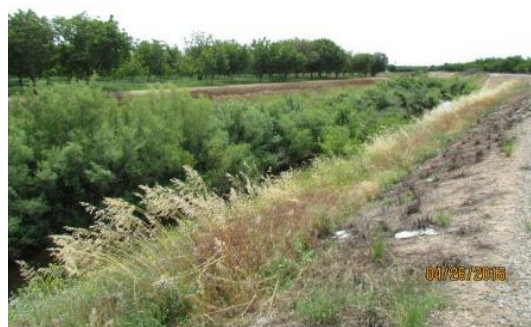
Photo 1 of 1 : SP_2016_NA0017_159_223_20160503_00317.jpg

LM Start	10.71	Rating **	M	Issue No.	223
LM End	10.71	Issue Type +	Ma	Location *	N/A
Category	Rivers, Channels & Designated Floodways			GPS Latitude/Longitude	
				Start	End
Item	Vegetation & Obstructions			37.963612 °	37.963612 °
				-121.156500 °	-121.156500 °
DWR ID	DWR_NA0017_15_s_2016_223				
Comment Code					
Inspector Comment					
Woody vegetation on the channel bank may impede the flow of the channel.

View of woody vegetation on the channel looking downstream.

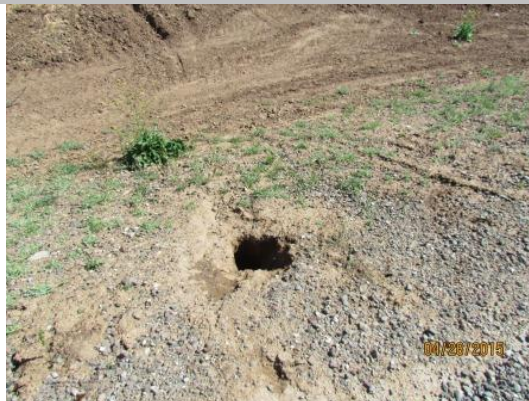
Photo 1 of 2 : SP_2016_NA0017_159_32_20160219_00048.jpg

LM Start	15.42	Rating **	M	Issue No.	32
LM End	15.42	Issue Type +	Ma	Location *	LS
Category	Earthen Levee			GPS Latitude/Longitude	
				Start	End
Item	Animal Control			37.975959 °	37.975959 °
				-121.235058 °	-121.235058 °
DWR ID	DWR_NA0017_15_s_2014_32				
Comment Code					
A3 : No rodents visible, but rodent burrows visible; need to backfill and compact or grout burrows.					
Inspector Comment

Updated picture of the rodent hole on the landside of the levee during spring 2015 inspection.
